## SWANSEA CITY AFC, LIBERTY STADIUM

### PITCH RECONSTRUCTION CONSULTANT

23rd August 2021

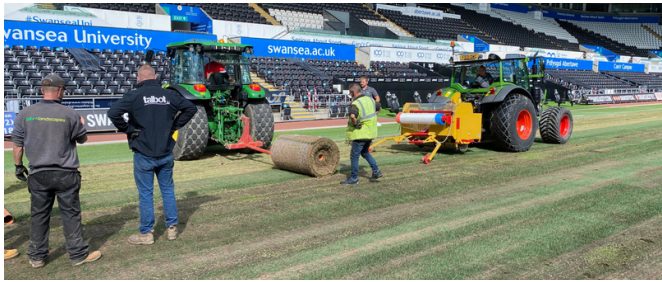
## REMOVAL OF EXISTING PITCH

The first stage after project scope was to remove the existing lay and play carpet and some of the existing base overlying the heating pipes. Review of contractors proposal and feedback on it. Vegetation was removed with a fraise mower to expose carpet hybrid backing, 4 days, carpet and infill was lifted and transported to the training centre where it was relaid.

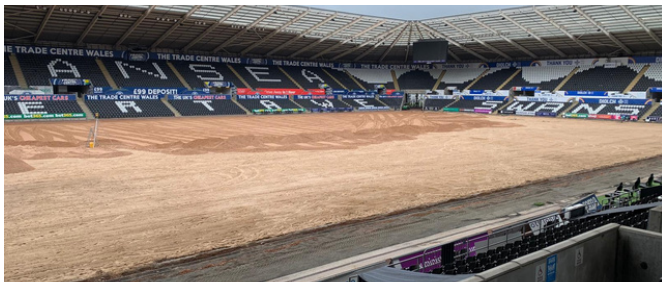
## IMPORTING NEW ROOTZONE

An upper rootzone of an zeolite ameliorated sand was imported and spread to final level with further independent key stage inspections. The material was checked for compatibility underlying sand.

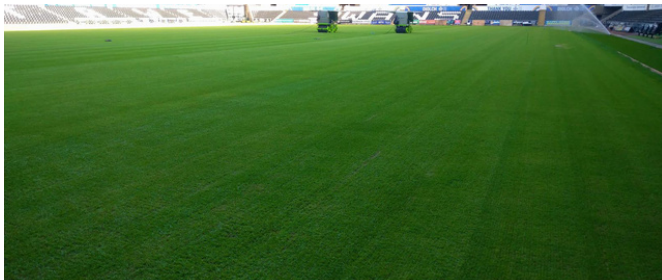
## HYBRID STITCHING

After the grass had sufficiently established the stitching of the turf was completed with SIS Grass fibres were stitched into the soil profile to a depth of 200mm. Approximately 5% of the surface is made up of artificial fibres.

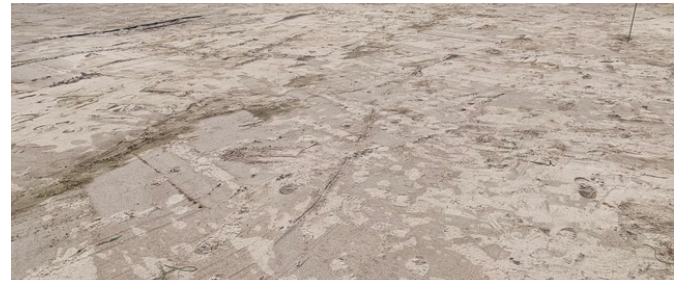
## EXISTING LOWER ROOTZONE

The existing lower rootzone consisting of sand layer over gravel raft and drainage network was then exposed and assessed for suitability in the new construction. Key stage inspections were carried out by ProPitch consultants including material taken offsite for identification and physical testing.

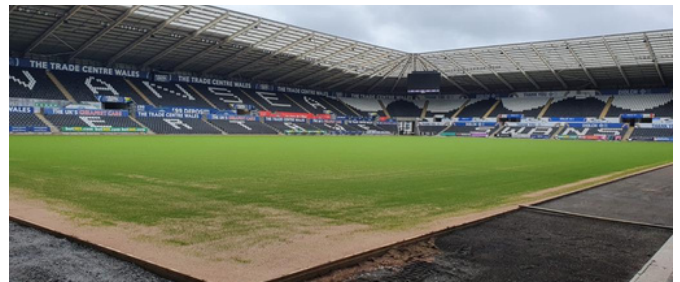
## GRASS ESTABLISHMENT

After the rootzone was imported and installed the grass cover was re-established from seed. The grass was allowed to establish for 3 weeks to achieve sufficient stability before stitching.
