SWANSEA CITY AFC, LIBERTY STADIUM

PITCH RECONSTRUCTION CONSULTANT

23rd August 2021

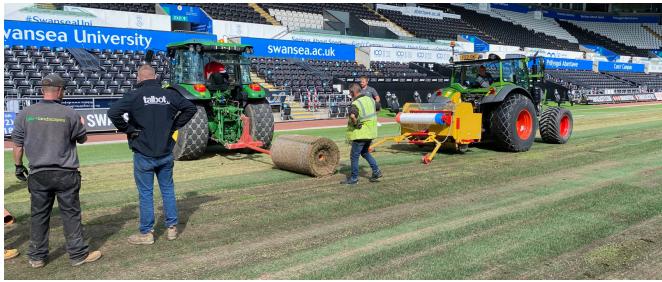
REMOVAL OF EXISTING PITCH

The first stage after project scope was to remove the existing lay and play carpet and some of the existing base overlying the heating pipes. Review of contractors proposal and feedback on it. Vegetation was removed with a fraise mower to expose carpet hybrid backing, 4 days, carpet and infill was lifted and transported to the training centre where it was relaid.

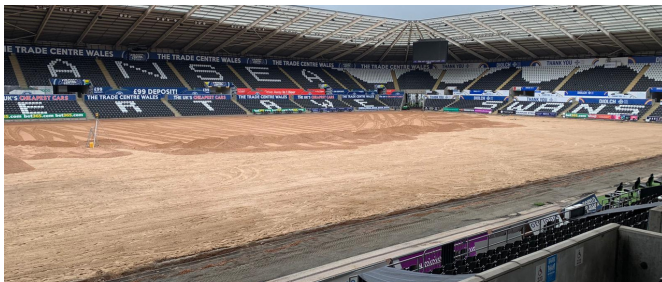
IMPORTING NEW ROOTZONE

An upper rootzone of an zeolite ameliorated sand was imported and spread to final level with further independent key stage inspections. The material was checked for compatibility underlying sand.

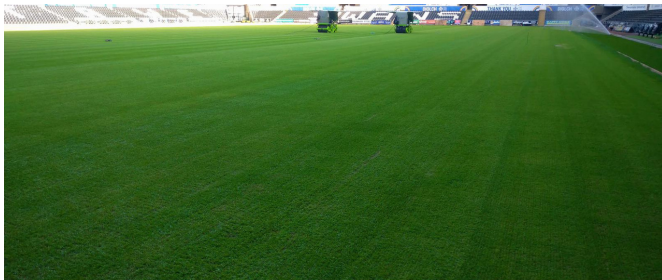
HYBRID STITCHING

After the grass had sufficiently established the stitching of the turf was completed with SIS Grass fibres were stitched into the soil profile to a depth of 200mm. Approximately 5% of the surface is made up of artificial fibres.

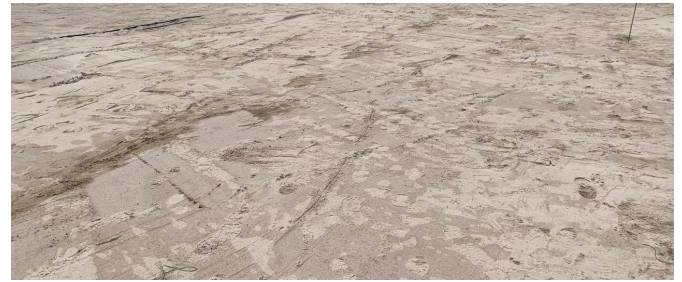
EXISTING LOWER ROOTZONE

The existing lower rootzone consisting of sand layer over gravel raft and drainage network was then exposed and assessed for suitability in the new construction. Key stage inspections were carried out by ProPitch consultants including material taken offsite for identification and physical testing.

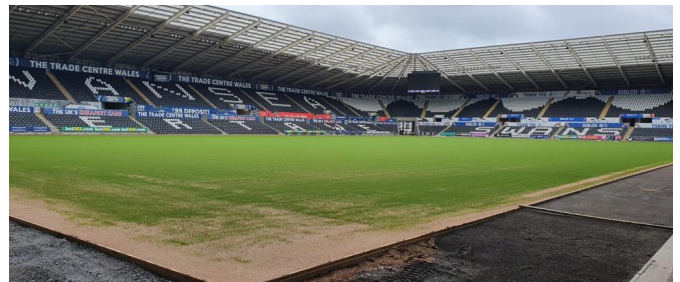
GRASS ESTABLISHMENT

After the rootzone was imported and installed the grass cover was re-established from seed. The grass was allowed to establish for 3 weeks to achieve sufficient stability before stitching.
